**12. THRIFT COTTAGE, WALTHAM ABBEY - NEGLECT OF GRADE II LISTED BUILDING (Pages 3 - 88)**

# THRIFT COTTAGE

## THRIFT COTTAGE, Sewardstone Road, Waltham Abbey, Essex, EN9 1NP

**Heritage Statement and Heritage Impact Assessment** to accompany submission of application forms and drawings for Listed Building consent for the demolition of the property

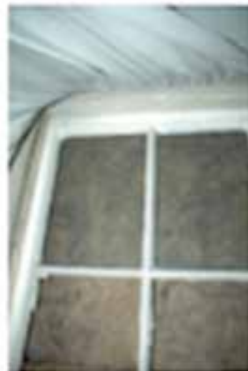
replaced widow frame with modern machined moulding

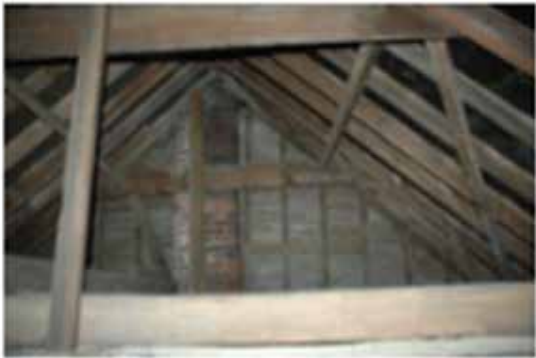
he main roof structure (double-pitch with gable chimnies) and covering has been completely replaced in recent years from eaves / top rail level with new softwood jack-rafters, purlins and collar-ties and ridge board, surmounted by heavy sarking felt, presumably battens, topped by plain clay tiles to the west elevation, and clay pantiles to the east. This exercise has removed a large amount of historic fabric and has unfortunately destroyed a good deal of the technological significance and value of the property. The eccentric loading of the roof does nothing to enhance its stability.

Looking NORTH

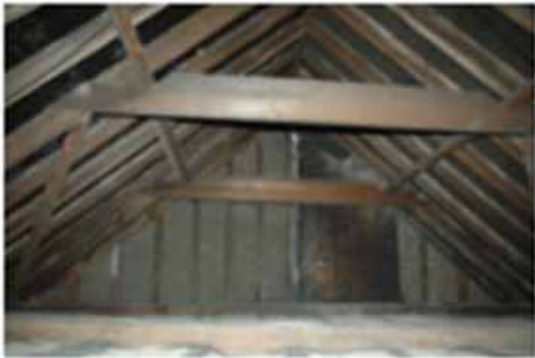
Looking SOUTH

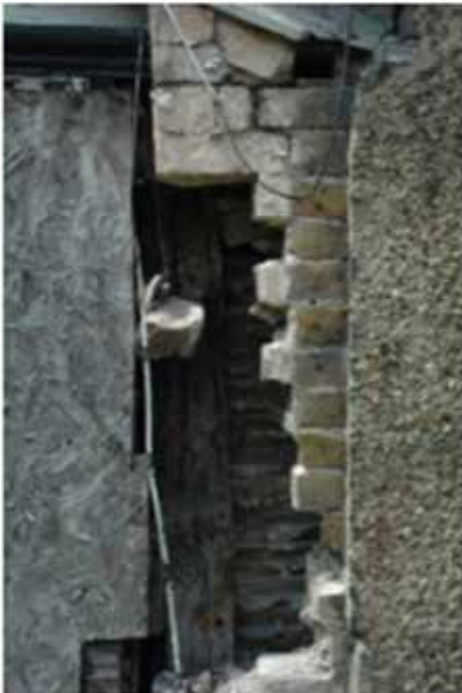
original rear door, internal studding and collapsing brick with render over

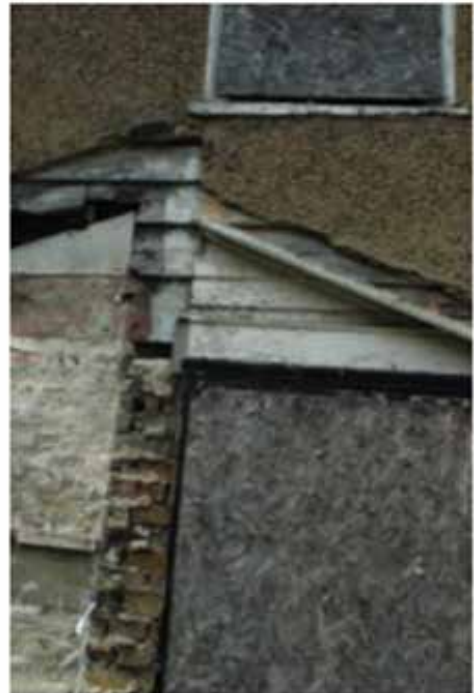
The 'outshot' accommodation to the South-East corner of the Ground Floor noted on historic plans and on the architects' sketches has been completely demolished and the profile of its former roofline is depicted in the elevational fabric.

outline of original rear outshot showing stepped opposing roof pitches

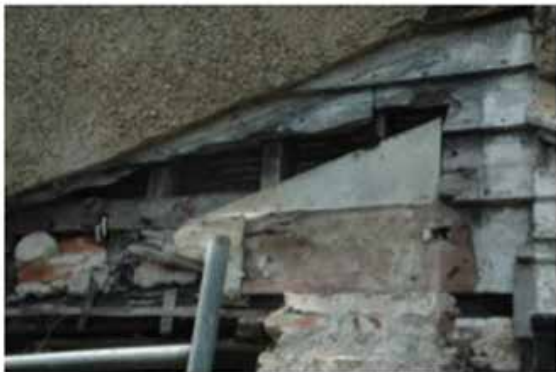
detail at First Floor intermediate rail

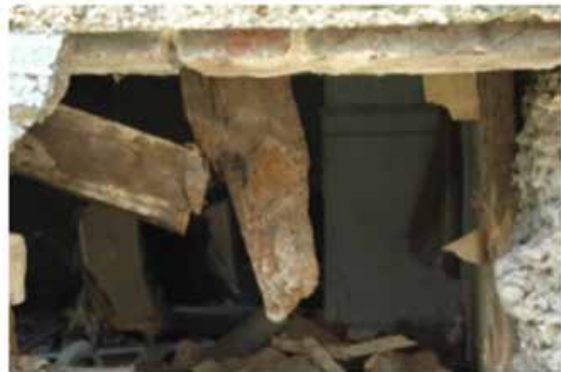
cross section view through ext.wall at rear
