## THRIFT COTTAGE, Sewardstone Road, Waltham Abbey, Essex, EN9 1NP

**Heritage Statement and Heritage Impact Assessment** to accompany submission of application forms and drawings for Listed Building consent for the demolition of the property

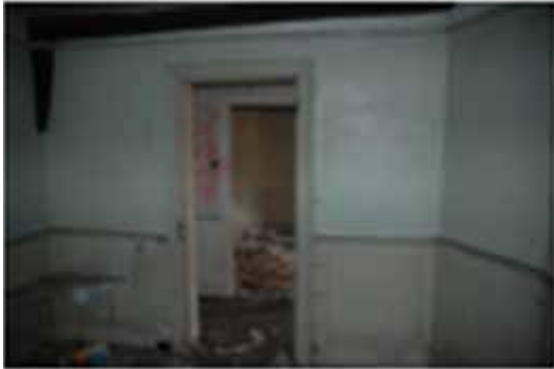
North wall with corbel bracket to LEFT

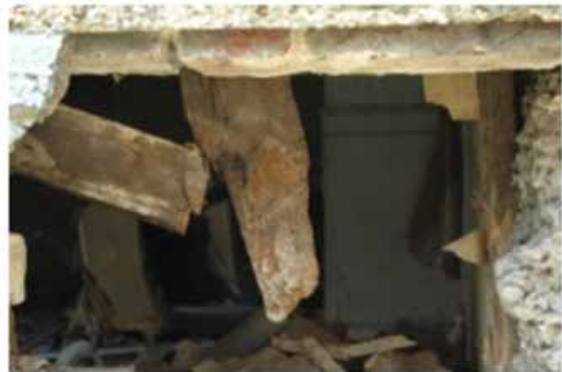
cross section view through ext.wall at rear
